FLOODPLAIN MANAGEMENT RECONNAISSANCE STUDY REPORT

CITY OF CHRISMAN
EDGAR COUNTY, ILLINOIS
FLOODPLAIN MANAGEMENT
RECONNAISSANCE STUDY

Prepared By

December 1984

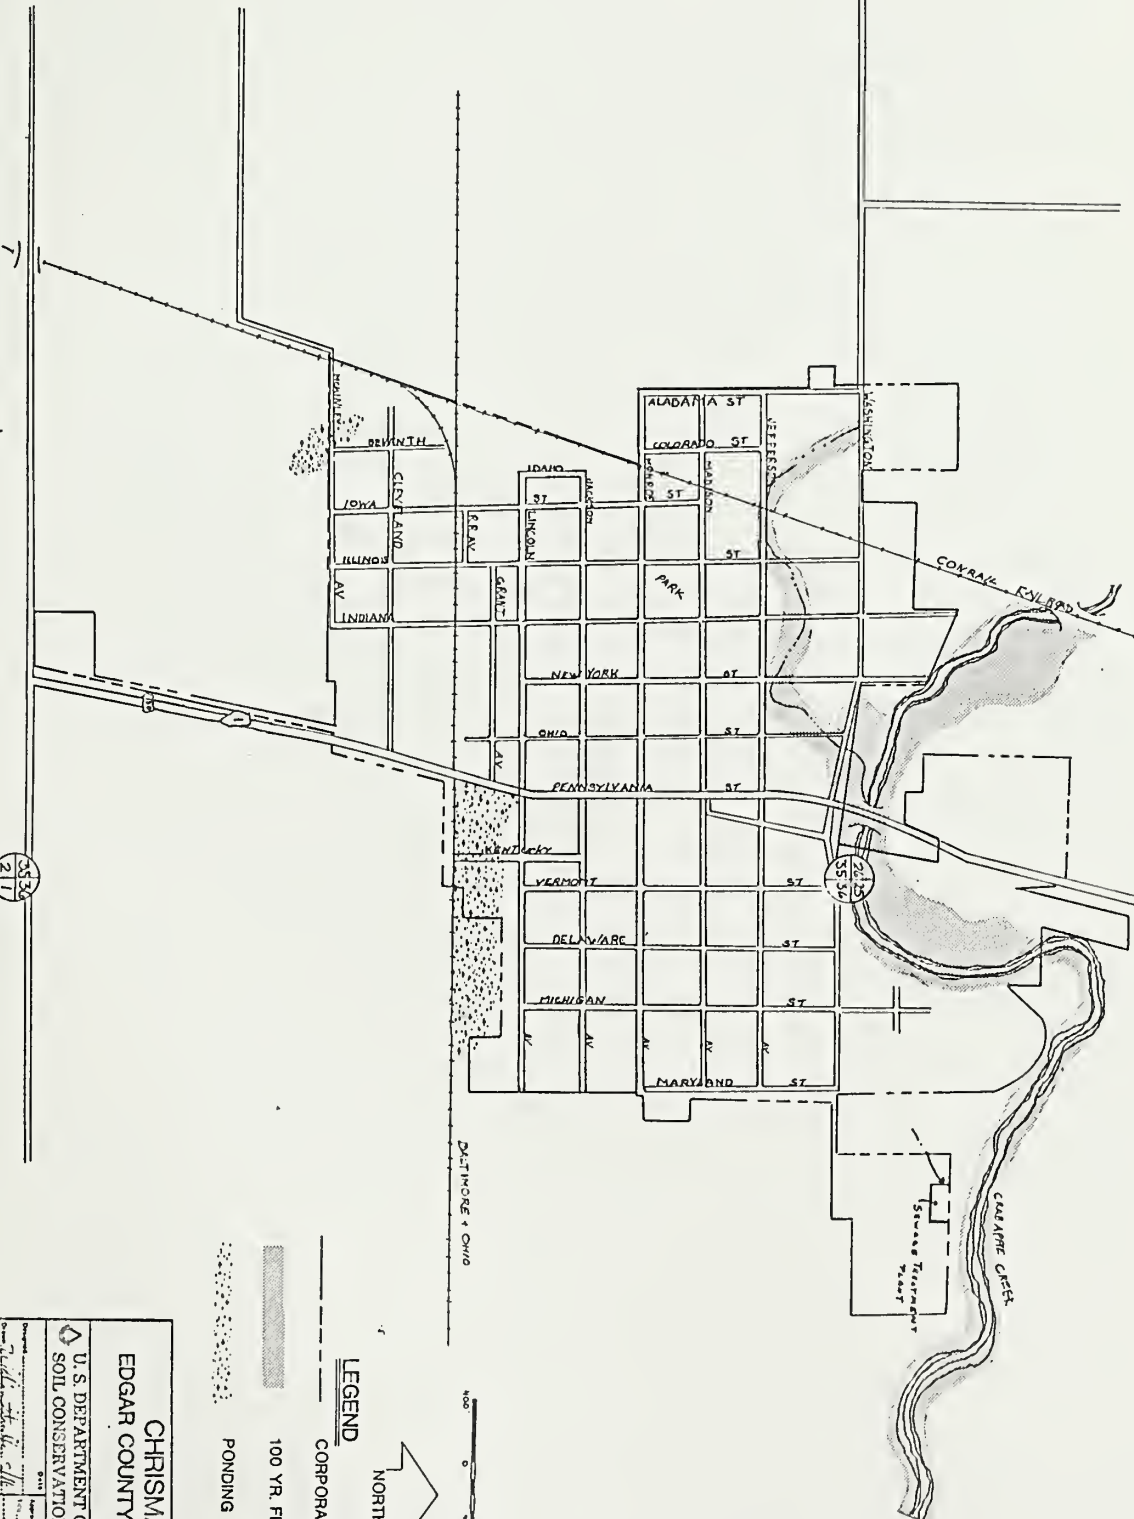
CHRISMAN
EDGAR COUNTY, ILLINOIS

100 YR. FLOODPLAIN

PONDING

This study was conducted and the report provided for the purposes of:
1) To evaluate needs for additional future studies, 2) to estimate average annual damages, 3) to provide an updated estimate of the 100 year floodplain and map, and 4) to provide guidance and recommendations to the community for improved floodplain management.

No additional calculations, discharges, or profiles were made as a part of this report. The inventory of flooding and water problems is based on a field review and interviews with local officials and citizens. To obtain the 100-year floodplain, information from local officials, citizens, and field review information was used. Aerial photographs were provided by the Division of Water Resources.
